Pre-Plaster Inspection Report

Dwelling type:	House and Garage.
Dwelling configuration:	Single Storey.
Nature of works:	New Building.
Stage of inspection:	Frame
Construction Type:	Brick Veneer.
Garage:	Attached.
Foundations:	Slab.
Builder:

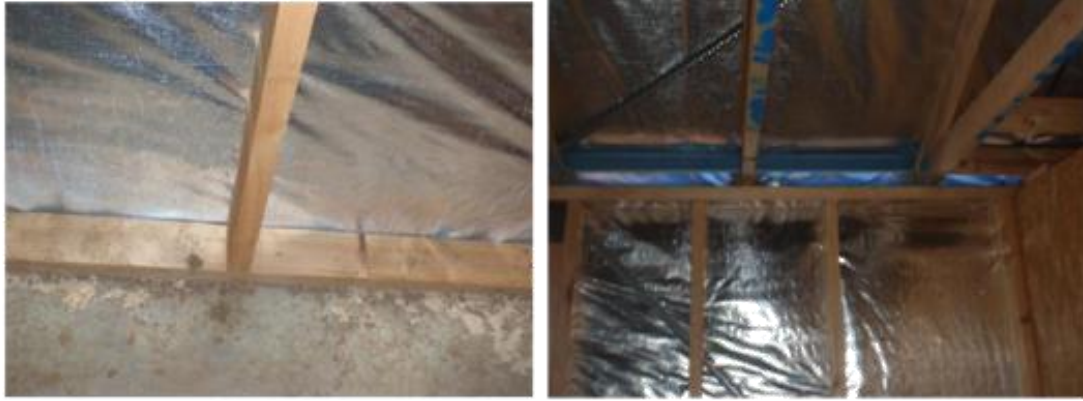
1. The tie down between the trusses/top plate & roof beams/wall studs/bottom plate is not continuous down to the floor slab.

Clause 9.6 Specific Tie-Down Fixing of AS 1684 Residential Timber-Framed Construction, states that 'Continuity of tie-down shall be provided from the roof sheeting to the foundation'.

All of these framing members will need to be properly strapped and tied to each other so that the sheet roof can resist the expected uplift from wind loads.

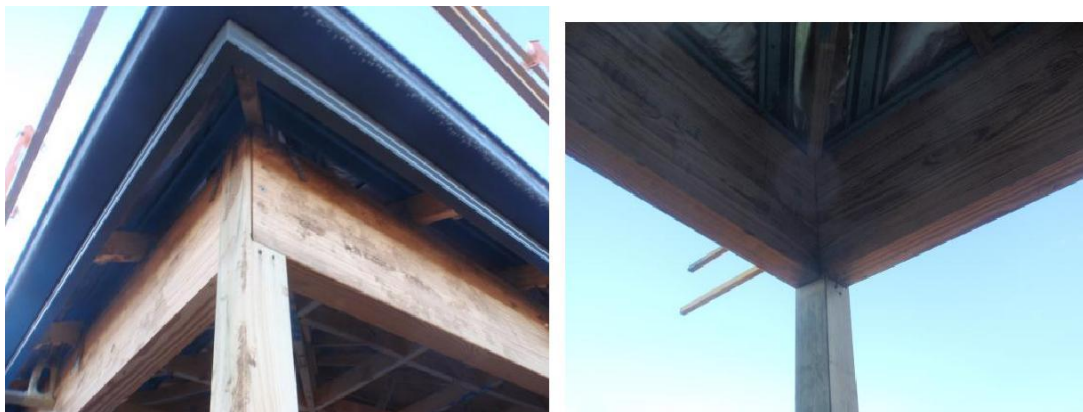
2. The roof beams over the portico and alfresco area has not been tied or bolted to the post supporting them.

I refer the builder to AS 1684.2, clause 9.5, and Table 9.4 under the heading of nominal fixings. It states; *Verandah beams and roof beams shall be joined to post with 1/M12 or 2/M10 bolts*. Nails and hooping iron are not noted on the Intrax engineering or the Australian Standard. To substitute hooping iron at the front or rear will require an engineering compliance assessment.

Please note that the alfresco has no bolt or hooping iron holding down the whole of the alfresco roof. Framing nails installed are clearly inadequate.

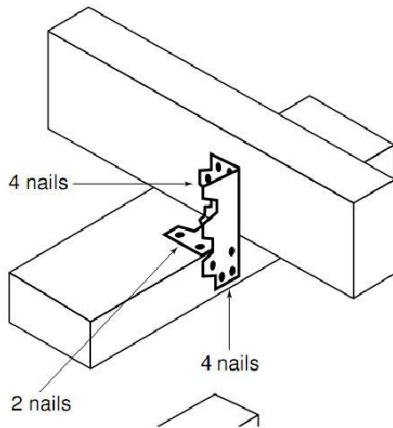
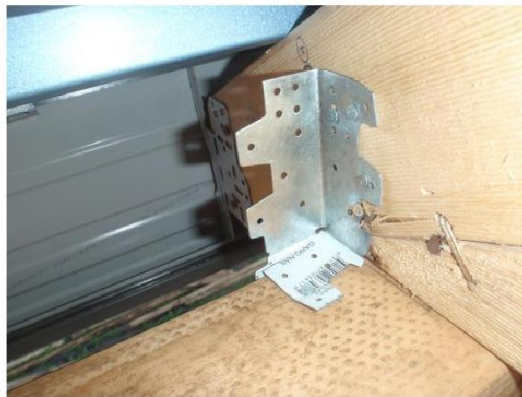
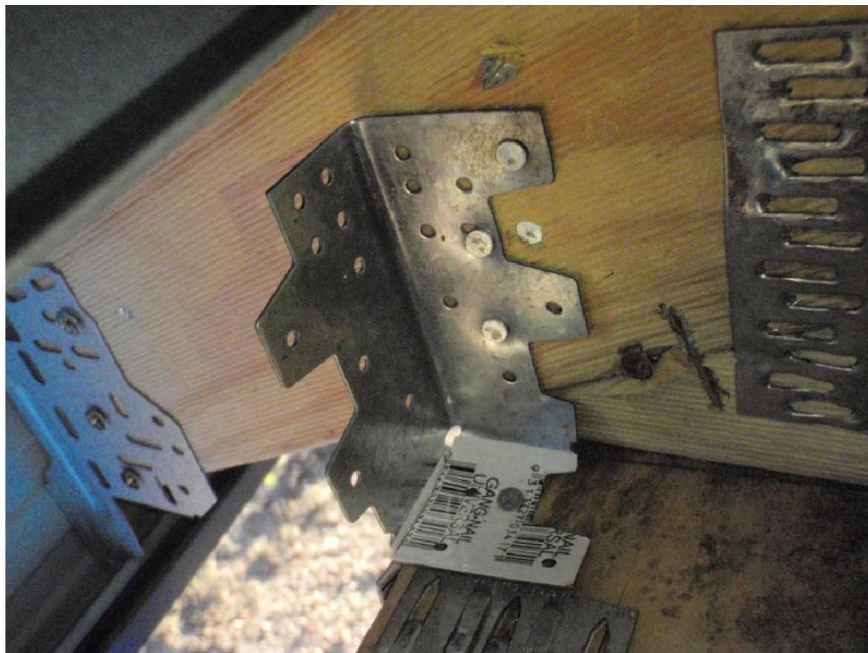
3. The gang nails universal brackets must be nailed with:
 - a. Four nails into the truss.
 - b. Two nails into the top of the top plate.

- c. Four nails into the side of the top plate.

As per the inserted pictures, I randomly checked several areas around the dwelling and found that the framer has not installed these essential brackets correctly and the trusses are not secured to the top plate of the dwelling in a manner that complies with the truss plan, supplier installation instructions and should not have passed the frame stage inspection.

This defect needs to be addressed prior to further works.

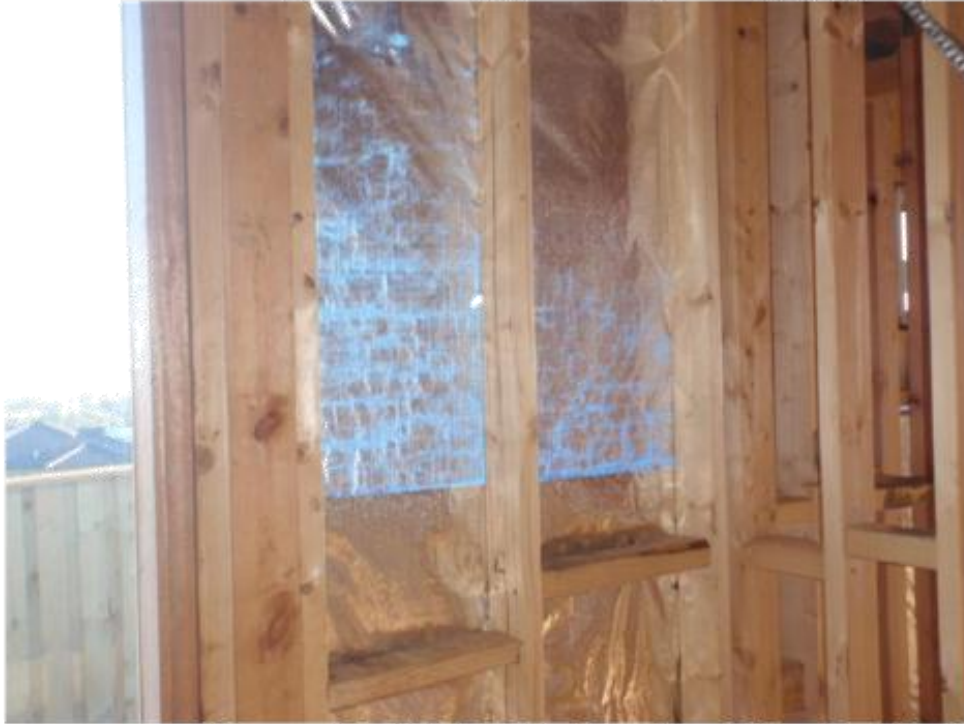
4. The sisalation to the dwelling has been damaged. It would appear that the sisalation has let go from the frame during a strong wind. As such the sisalation has delaminated the foil coating.

The sisalation is therefore damaged and cannot be made as new. The damaged sections will need to be replaced with new prior to proceeding with the build. I refer the builder to section 11 of the contract and section 37.2.

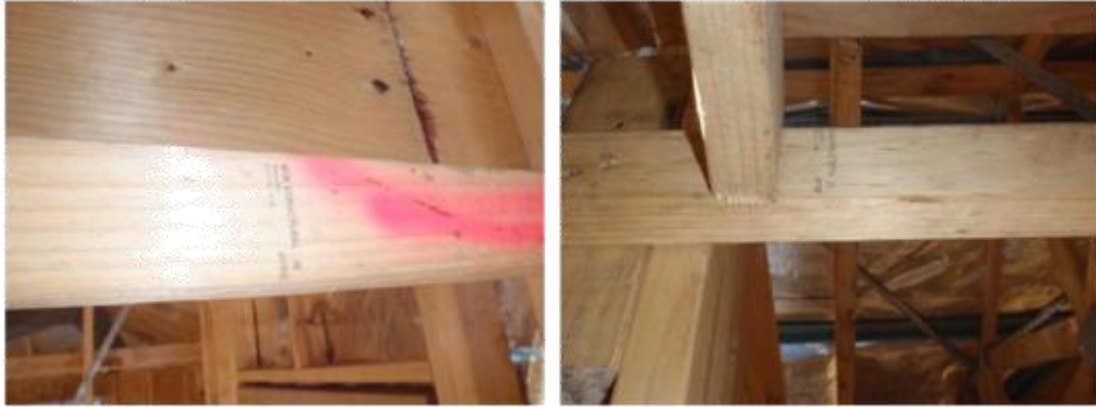
5. The framing of the ceiling in the bedroom 1 and study to hallway connection has been constructed from what appears to be Merch Pine. That is pine that is non-structural rated and cannot be installed into a dwelling for this purpose.

AS 1684.2 calls for structural wood to be used in all framing applications other than noggings.

The use of any material that has been marked up at some point as being non-structural is of a major concern. This material installed has “Non Structural” clearly printed on same.

It is my recommendation that my clients seek to have the material removed from site and replaced with material that is clearly marked as being fit for purpose.

I further recommend that any supplication to leave the existing material in place is rejected and that no supporting documentation would comply with the requirements of the Australian Standard.

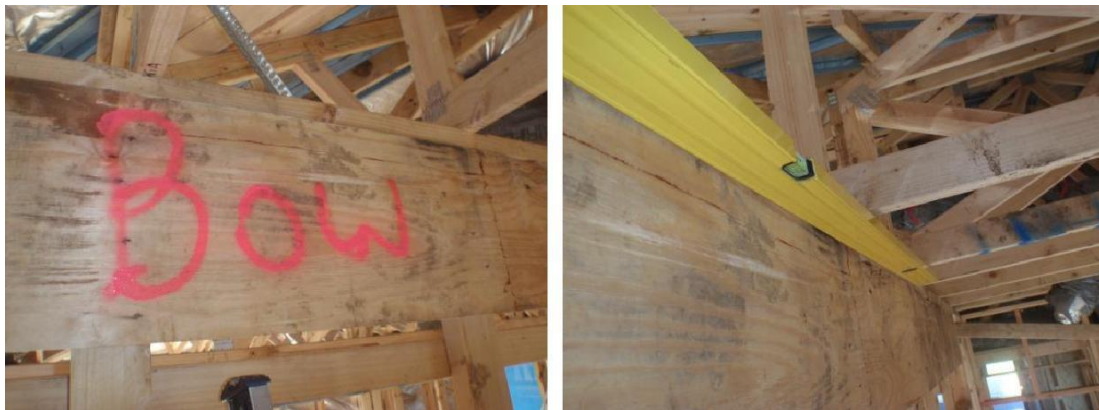
6. The LVL to the study opening has a bow in the installation that was noted at approx 10 mm over 2 m. The allowance in AS 2589, clause 4.2 and table 4.2.2 is 4 mm over 2 m.

The beam will need to be made straight to the tolerance or replaced.

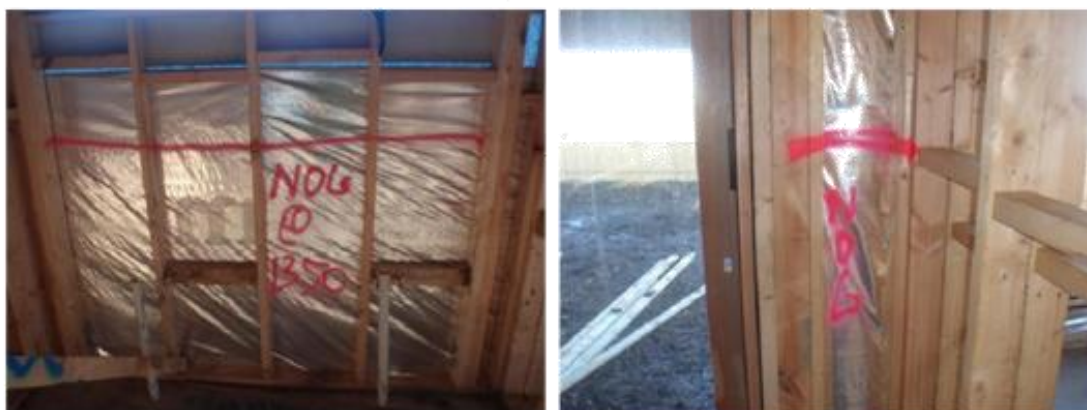
7. There are several noggings that need to be installed or in parts reinstalled.

I noted that the ensuite noggings have been installed at greater than 1350 mm separation.

I refer the builder to AS 1684.2, clause 6.2.1.5 which calls for all noggings to be installed at no greater than 1350 mm from top or bottom plate and no greater than 1350 centres.

The missing noggings will need to be installed as marked up on site prior to lockup completion.

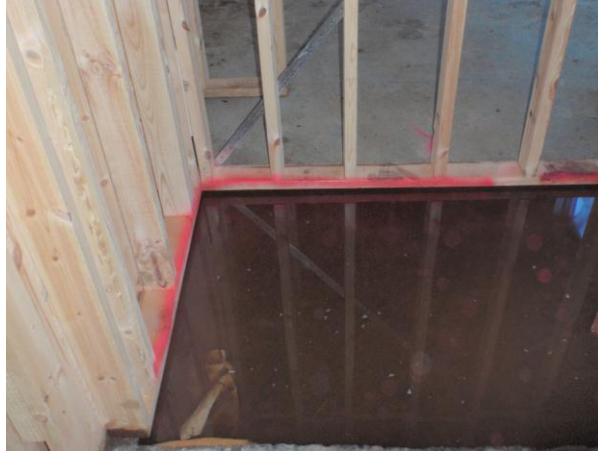
8. The frame overhang to both shower recesses needs to be supported in a manner that complies with As 1684.2, clause 6.3.3, and the BCA. I would suggest that a 100 MPA non-shrink grout is installed.

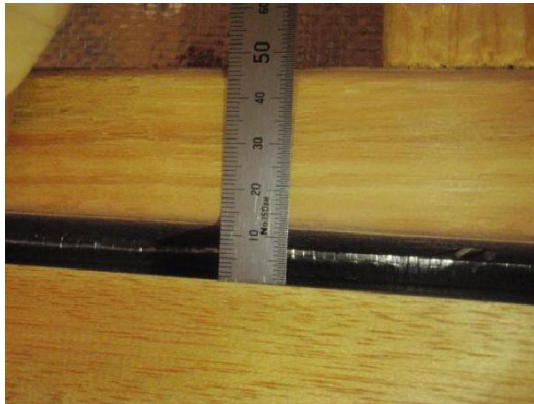
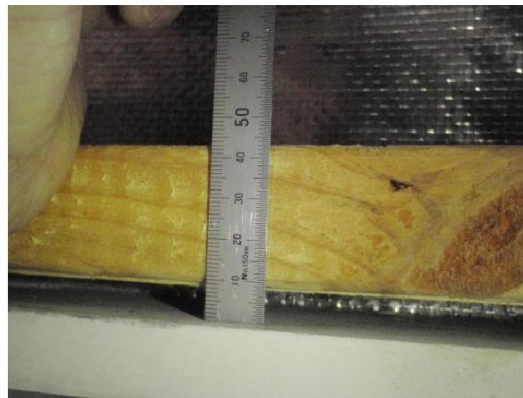
9. As per section 9 of the Southern Star window installation manual, the head clearance should be 13 mm for timber windows and 6 mm to both sides.

I noted that the installed windows to several locations do not meet this minimum allowance for gapping. The frames to these windows will need to be reworked to ensure that my client's windows are installed as per supplier instructions.

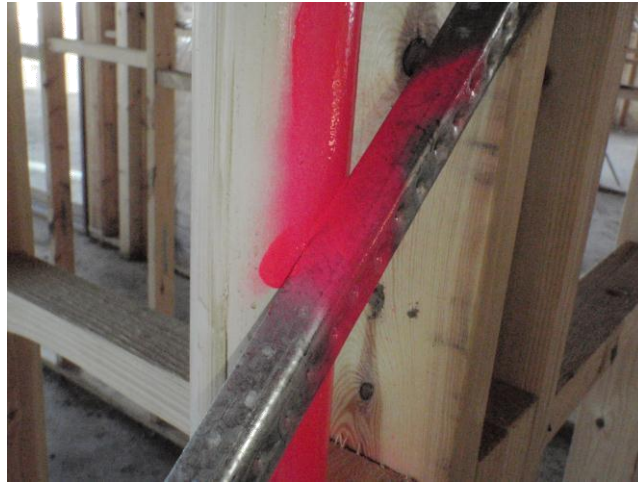
10. The conflict between the bracing and the venting pipe in the bathroom will need to be reworked. Please note that cutting the bracing will need to be supported with additional engineering.

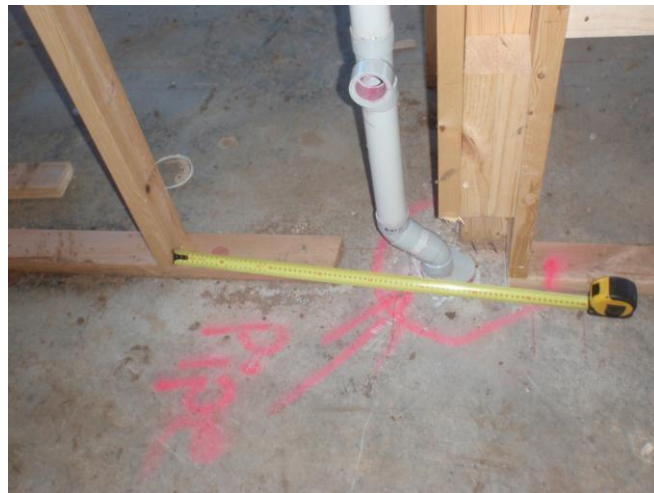
11. The stud to the bathroom wall has been cut at the junction removing approx 200 mm under the stud.

This has resulted in an opening between the studs greater than 600 mm. I measured approx 650 mm. An additional stud will need to be installed to the other side of the pipe for the minimum of 600 mm to be maintained.

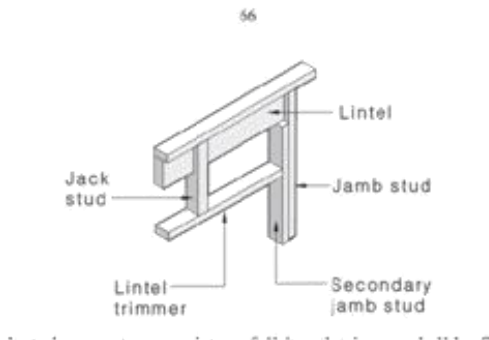
12. The jack studs under the lintels must be installed hard under the lintel or an additional section of timber installed so that the brick layer has a connection point for the brick ties. We refer the builder to AS 1684.2, clause 6.2.3 which calls for all jack studs to be the same orientation as the standard studs, however does not make same compulsory.

However, given the requirement for the brick ties to be doubled up around windows and doorways, the only way to comply with this mandated requirement is to install additional material to the jack studs or rework the manner in which they are installed.

Failure to install or rework this item will result in a later defect on the brick tie requirements above all openings.

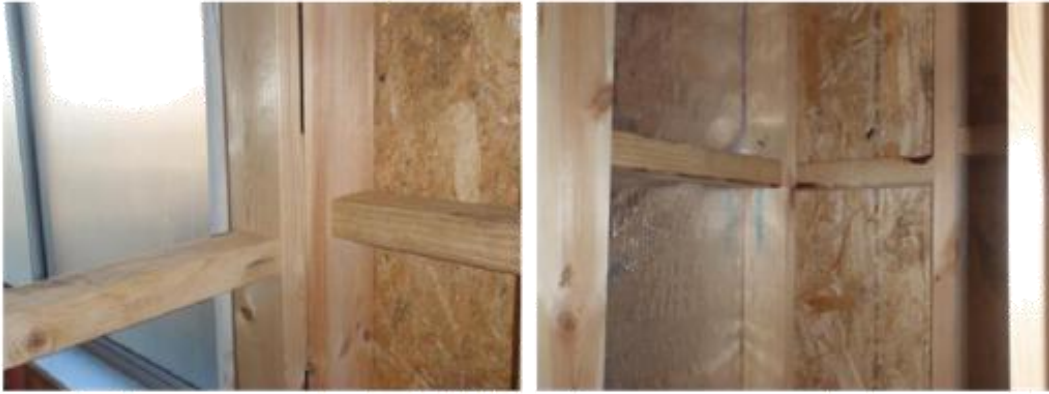
13. It appears none of the external walls on the dwelling have been nailed off. Section 9.5 and table 9.4 of AS1684.2, and section 6.2.1.3 of the same document states all connecting walls must be secured and nailed in accordance with both clauses.

The frame pass should not have been approved without this element being installed.

The builder may claim that this will occur at lockup stage. However this procedure fails to take into account, what holds the dwelling up in the time between now and lockup stage completion?

As a minimum the builder must nail off the external walls to ensure that the dwelling can resist the racking forces that AS 1684.2 mandates. The internal walls can then be finished off at lockup stage.

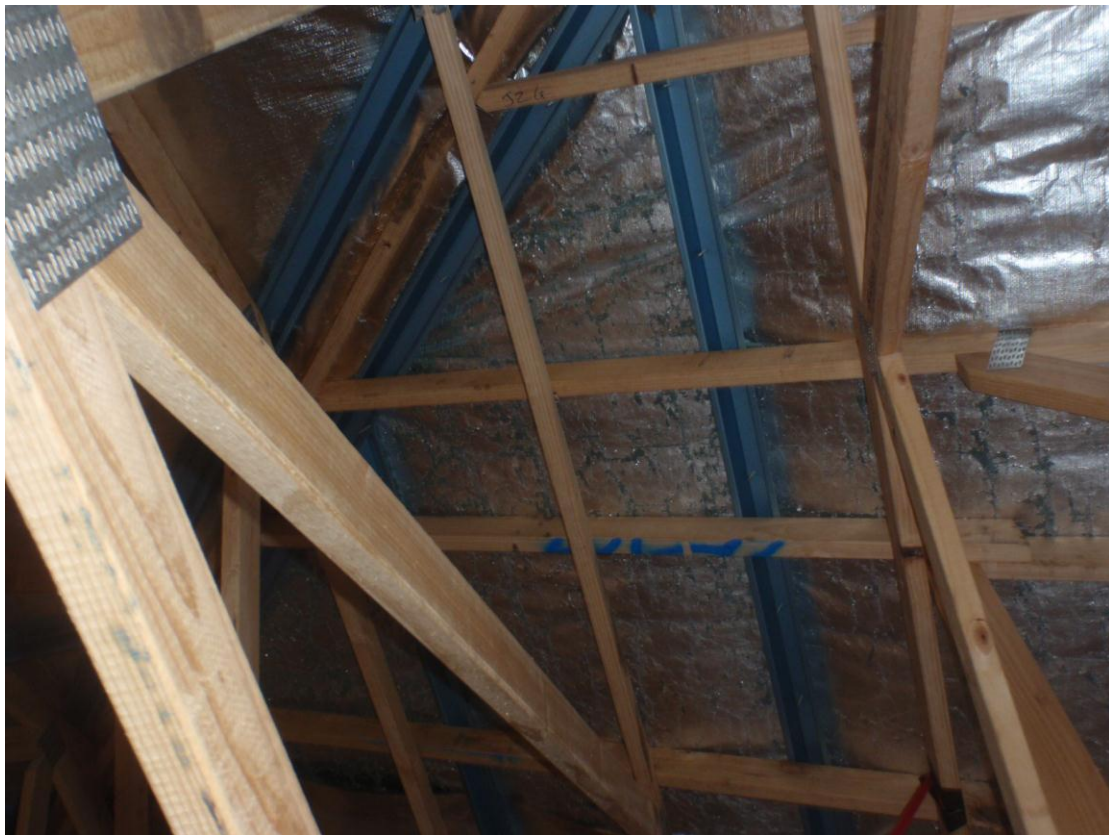
14. The sarking to the dining / rumpus roof area has been damaged and is missing the foil coating. The sarking needs to be made as new or replaced. It is impossible to make new this item and it is my opinion that it is replaced.

I refer the builder to section 11 of the contract. All materials will be new. I also noted that the dwelling has a BAL of 12.5 and this item make up part of that installation. It must be reworked.

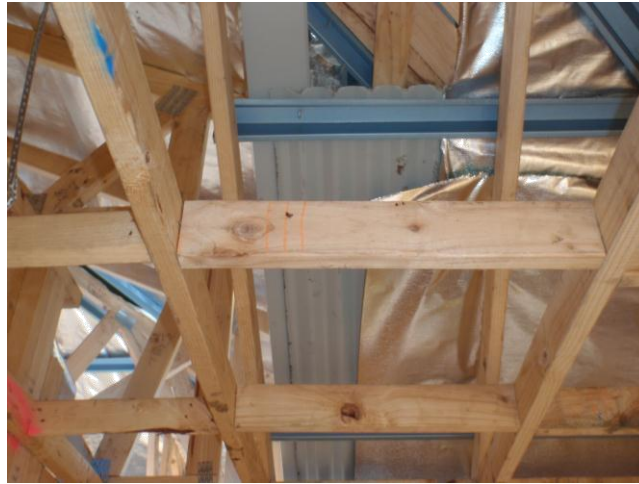
15. The sarking to the study is missing to a small section. The sarking to this area must be installed. I noted that the dwelling has a BAL of 12.5 and this item make up part of that installation. It must be reworked.

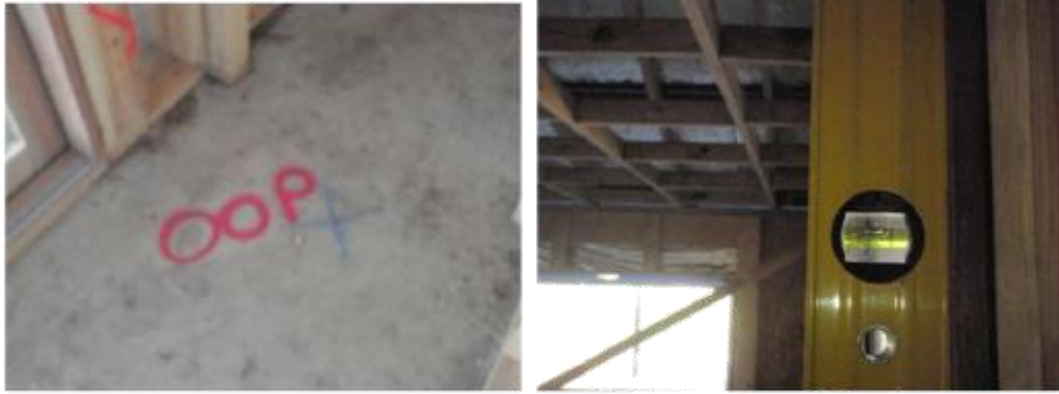
16. The installation of a door cavity unit to the pantry that has been installed beside the void and in front of the drop ceiling in the kitchen will result in external and internal air leakage due to the configuration of the installation.

Note that air can pass via the void opening and hence the energy rating on the dwelling has been compromised.

The cavity must be sealed prior to closing off the walls with plaster. I refer all to the BCA part 3.12.3.5.

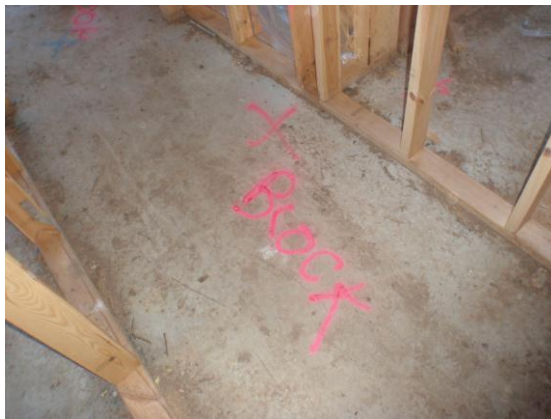
18. I intersecting wall block is missing from the wall connection at the rear hallway to dining room connection. It must be installed prior to plaster.

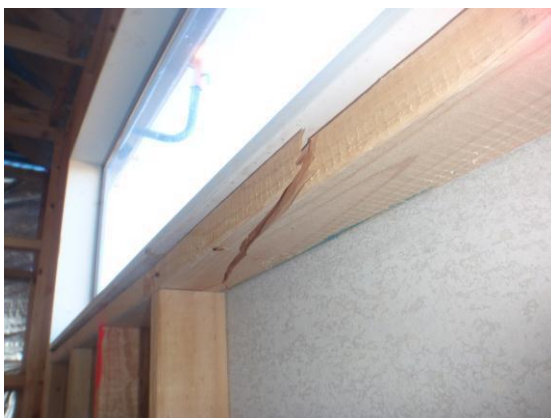
19. The bedroom 4 window timber sill plate has been damaged and will need to be secured prior to plaster.
