Dwelling type: Dwelling configuration: Nature of works: Stage of inspection: Construction Type: Garage: Foundations: Builder: House and Garage. Single Story. New Building. Frame. Brick Veneer. Attached. Slab. Details hidden for privacy

Client Brief

An inspection was conducted at the above address on 04/08/2014 for the purpose of a general home inspection, requested by the client.

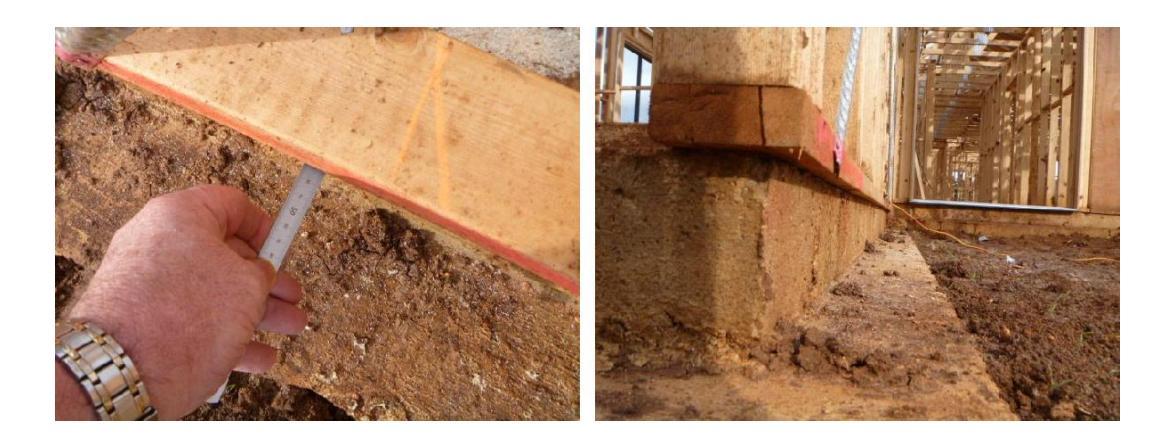
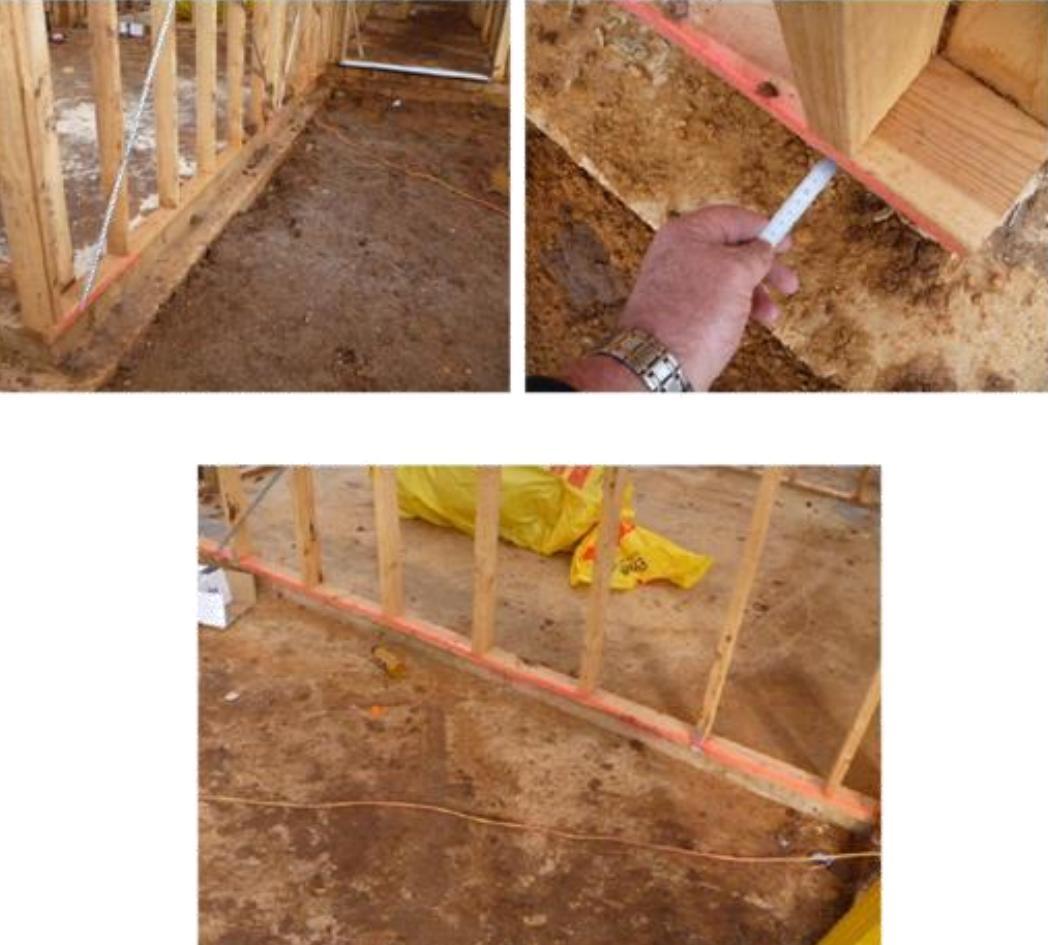
1. There is frame overhang to the slab edge of between 20 to 30 mm in various positions around the home. These areas have been highlighted with pink spray paint.

The Building Commission's Guide to Standards and Tolerances clause 4.08 Bottom Plates that Overhang Concrete Slabs, states 'Bottom plates that are at least 90mm wide and overhang concrete slabs are defective. An overhang of up to 10mm is permissible'.

This overhanging bottom plate will need to be supported by an appropriately designed and certified engineered system so that it complies with As 1684.2, clause 6.3.3, and the BCA.

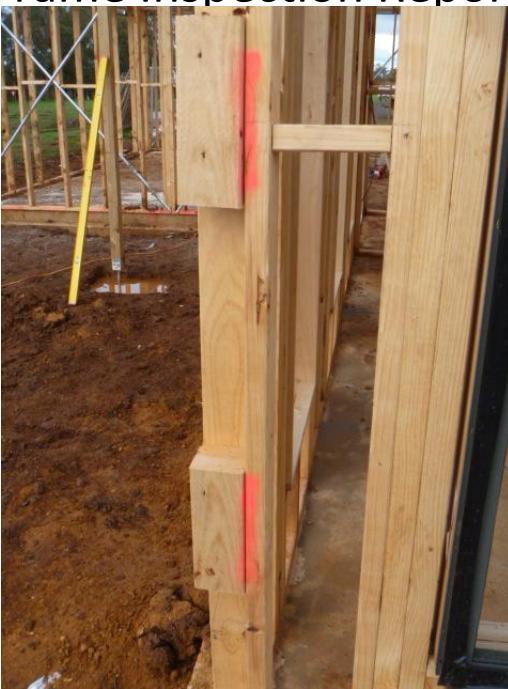
2. I checked a large number of intersecting wall block connections and noted that none had been nailed off.

Most builders leave this until lock up stage so that the walls can be easily straightened and plumbed at the connections, however the framing Standard requires this to be done to pass frame inspection.

It is my recommendation that the builder as a minimum secure all external walls only as per the Australian Standard at this time and this will allow the lockup carpenter to accomplish his task to all internal walls.

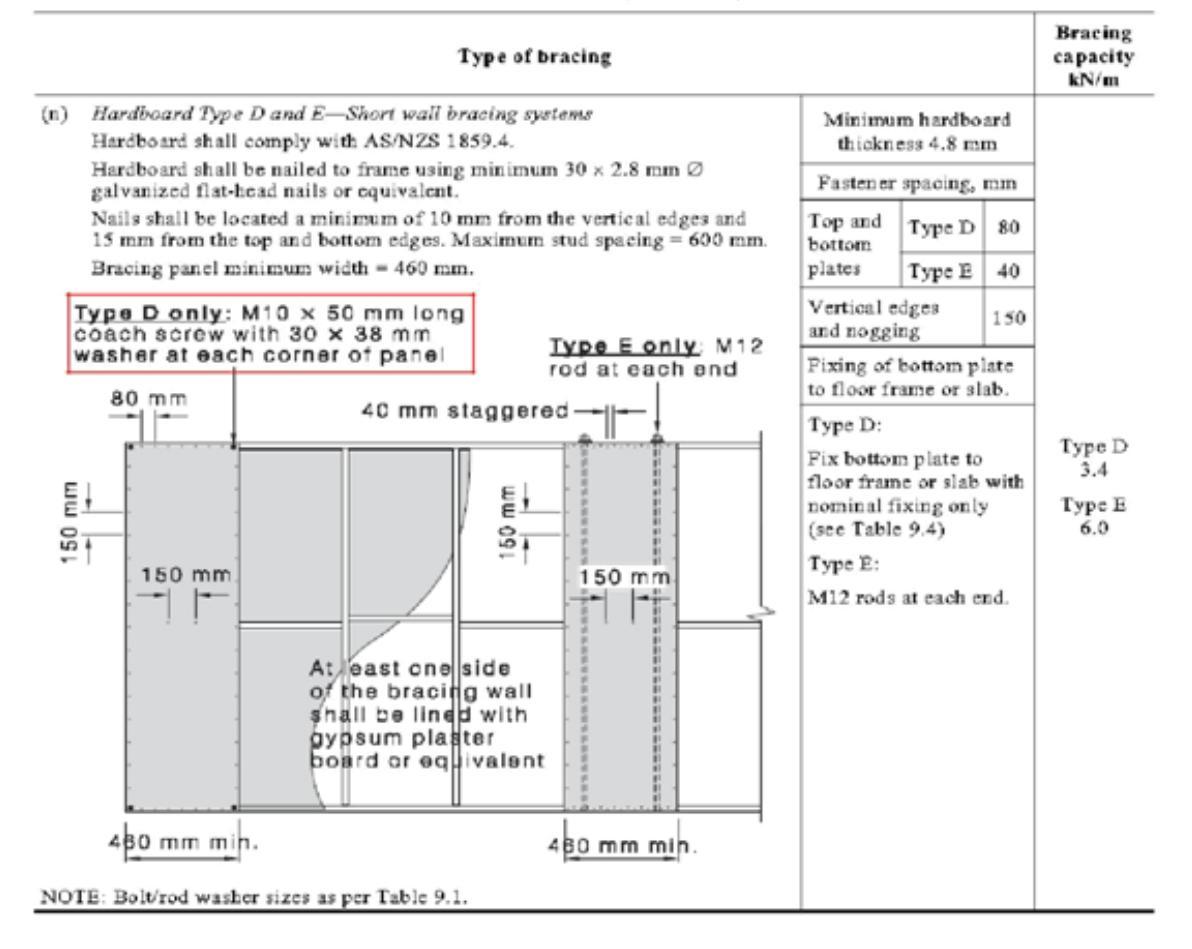
3. The dwelling has numerous 'short wall' sheets of hard board bracing ply measuring less than 900 mm.

As per the AS1684 bracing guidelines any type 'D or E' short wall bracing below 900mm in width is required to be screw fixed at its outer most corners top and bottom with M10 x 50mm screws. Or alternatively two full lengths of M12 treaded vertical rods.

Type A, B or C bracing cannot be any less than 900mm in width, if the sheeting is less than 900mm then it is to be installed as type 'D & E' short wall bracing and has to be installed as per section (n) of table 8.18.

The builder will need to install the corner bolts (type D) or full length threaded rods (type E) as per the AS 1684 - (n) 8.18 requirements

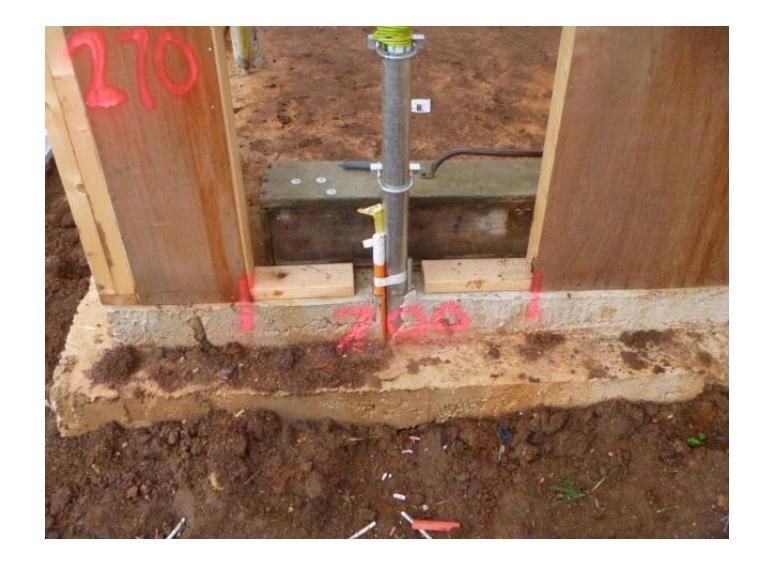
4. The wall at the meter box has studs spaced at 700mm. The maximum allowed stud spacing in the AS1684 standards is 600mm centres.

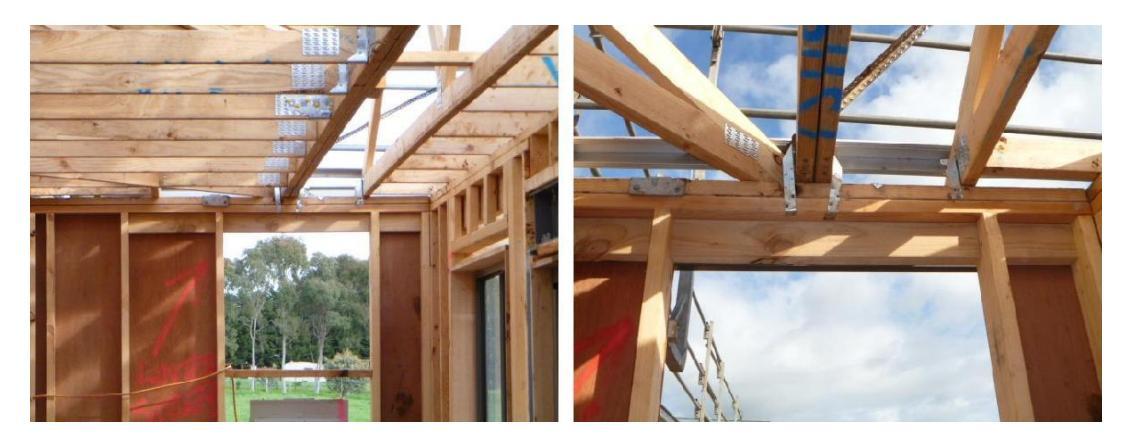
5. The 90 x 35 pine lintel above this meter box showing visible deflection directly under the girder trusses.

This double girder also intersects the main girder across the home.

This load point is carrying a very large amount of roof weight and will require a lintel much heavier than is currently installed.

The builder will need to justify this new lintel installation with reworked engineering documentation.

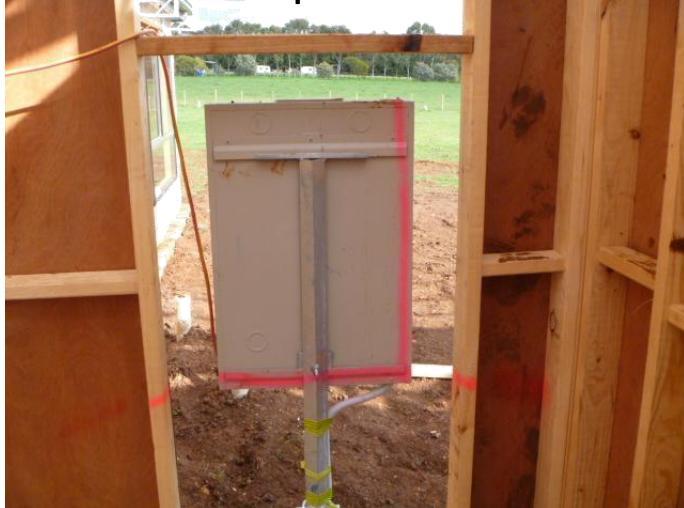
6. The timber frame wall at the meter box will need the installation of noggins at the bottom and top of the box to comply with the 1350 maximum spacing requirement.

I refer the builder to AS 1684.2, clause 6.2.1.5 which calls for all noggings to be installed at no greater than 1350 mm from top or bottom plate and no greater than 1350 centres.

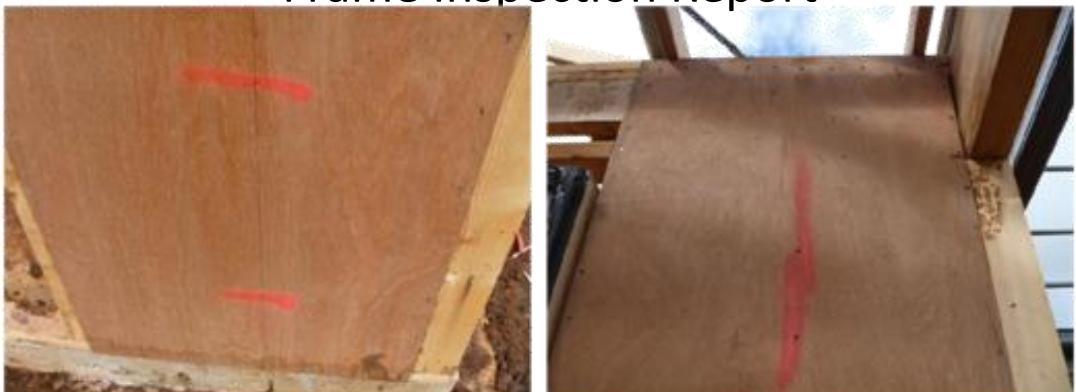
7. The timber sheet bracing installation is a vital structural member in the overall build of the dwelling. It stops the house from moving when racking forces, such as wind, are applied to a dwelling.

The installation of the timber sheet bracing on this house is defective for the following reasons:

- Many of the clouts fastening the sheet bracing have been over punched. When these clouts are punched so far into the sheet bracing it makes the fastening ineffective. Extra clouts will need to be installed to comply with the AS2684.2 bracing guidelines.
- The outer sheet edge must be secured at a maximum of 150 centres. This dwellings installation fails that requirement.
- The central studs must all be nailed off at 300 mm centres maximum. This has not been done.
- Complete or part lengths of the sheet have not been nailed off at all.
- Some of the intermediate studs have not been nailed off and as such the nailing is spaced at more than the allowed 600mm spacing.
- Some of the perimeter nailing is within the 10mm minimum distance from the edge of the sheet.

I refer the builder to AS 1684.2, table 8.18 on page 143. The requirements stated above are clearly defined and must be rectified prior to moving forward with the dwelling.

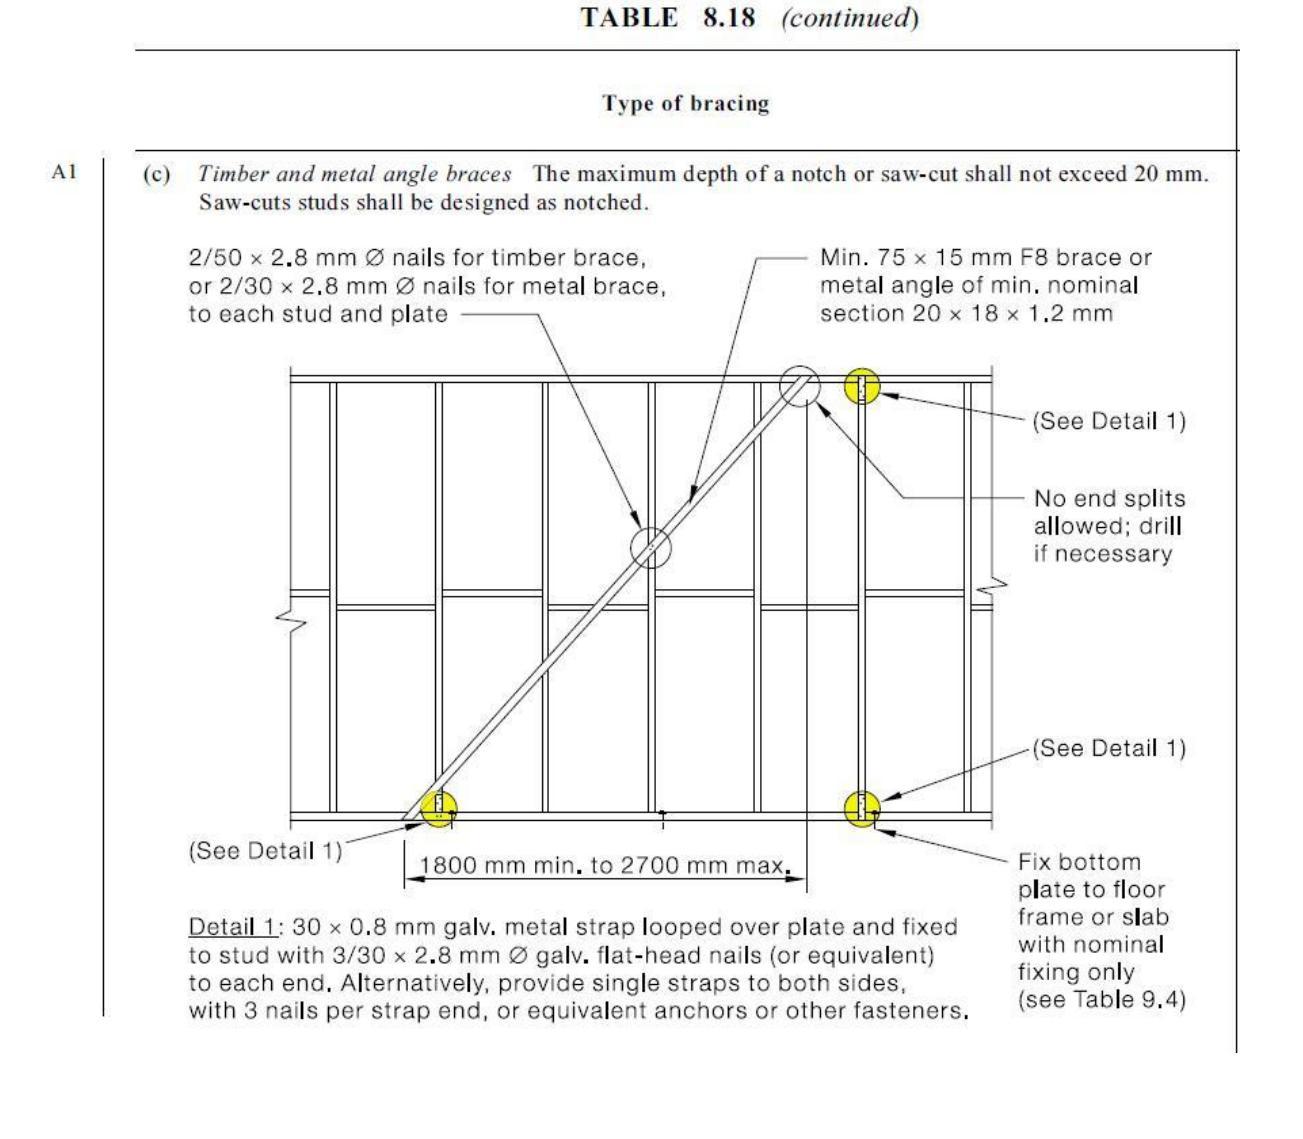
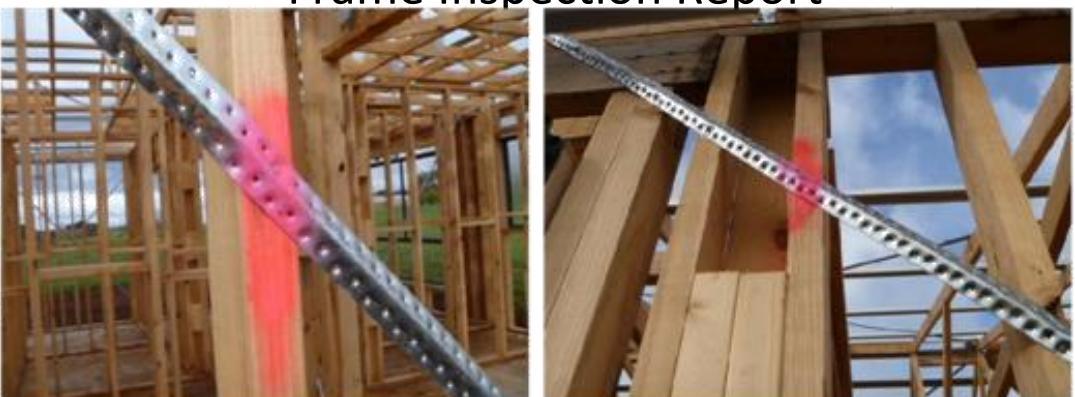
8. Some of the angle braces and speed braces have only a single clout or none at all at the studs.

Two clouts are required at top and bottom plate and <u>each</u> stud for correct securing of the braces as per AS1680.2 - 2006

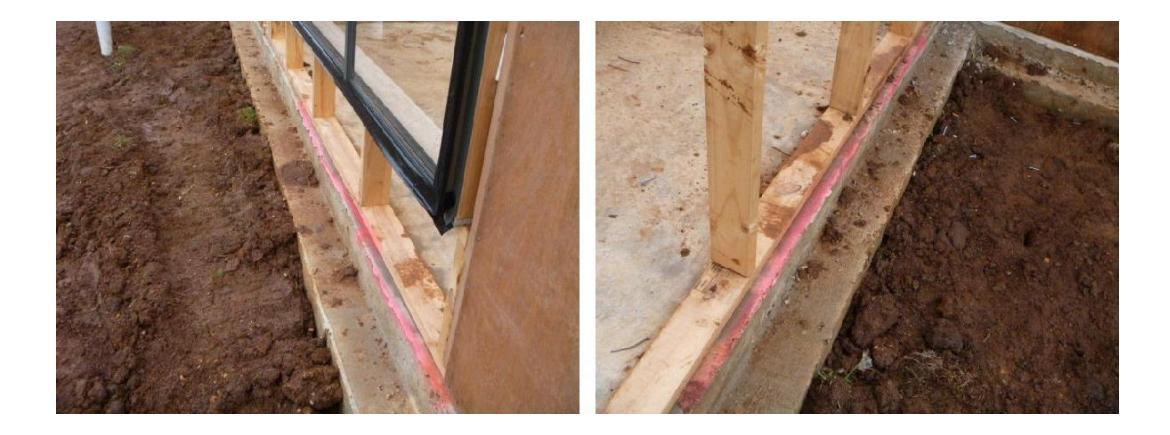
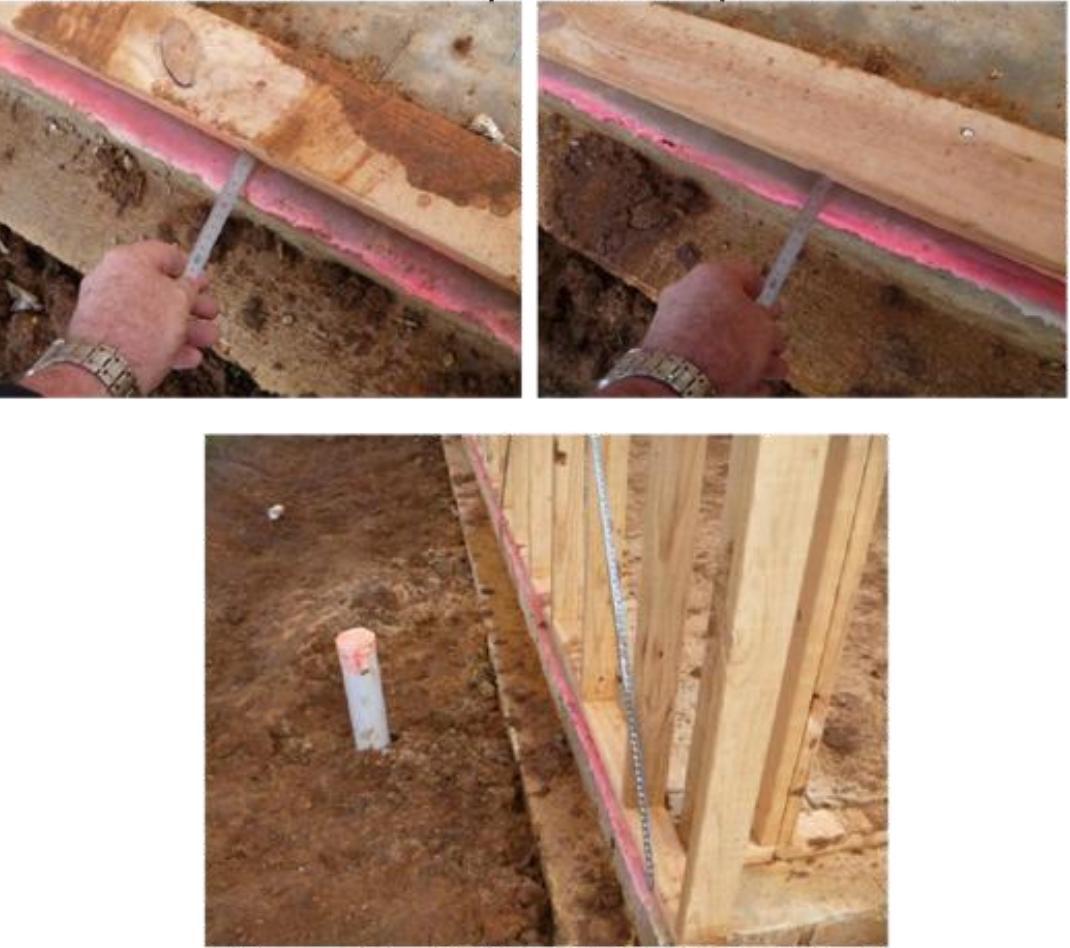
9. The LHS of the home has concrete boxing excess of approximately 25mm.

The edges of the floor slab have not been correctly boxed up prior to being poured, which has resulted in it protruding out past the pine wall frame by up to 25mm which will significantly reduce the required 40mm cavity width across to the back of the brickwork and compromise its ability to drain any water and moisture that collects in it away from the timber wall framing.

Part 3.3.4.2 Width of Cavity of the BCA/NCC, requires that 'In brick veneer construction, a cavity of not less than 25mm width must be provided between the inner and outer walls and the minimum cavity width is to be maintained between the outer masonry leaf and any services, insulation, sheet bracing or other element located within the cavity'. Additionally, the relevant Australian Standard, A.S.3700-2001 Masonry Structures, clause 11.4.13 Cavities in Walls, requires that 'Cavities shall be free from mortar droppings or other materials that might bridge the cavity and allow transmission of moisture'.

The builder should therefore, after consultation with the slabs design engineer, carefully trim back the edges of the slab to achieve the required minimum 25mm cavity width, at least down to below the damp-proof course/cavity flashing. Consideration should be given to not exposing the edge of the steel reinforcement or reducing its side cover; not reducing the throat of the edge beam; and also to any protrusion that may exist on the lower edge of the rebate out past the future finished face of the brickwork.

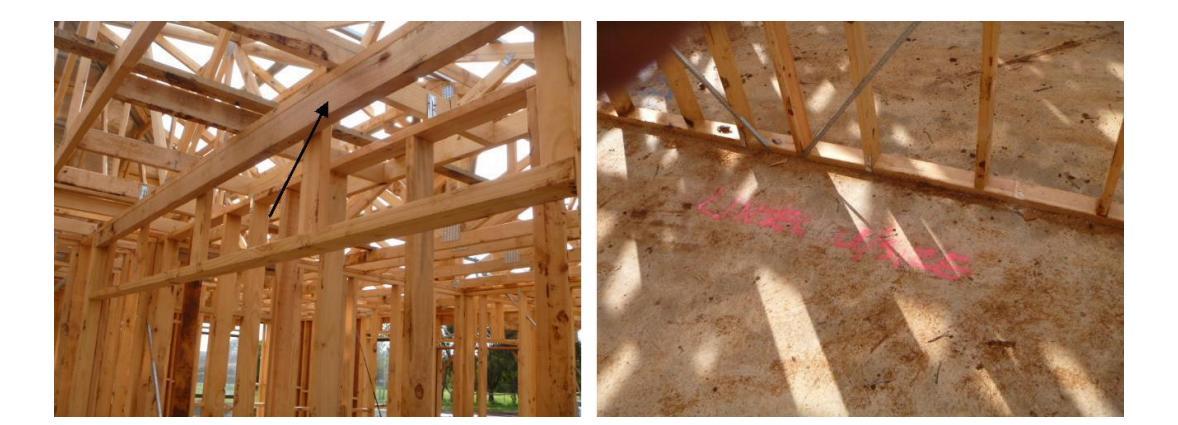
13. Theatre - The robe opening measures at 3210mm and as such will require installation of a larger lintel than currently installed.

AS 1684.2-2010 states that when openings in NON-LOADBEARING WALLS over 1800mm occur, both internal and external, a lintel shall be installed and the size of the lintel will be determine by table 23, based on the top plate.

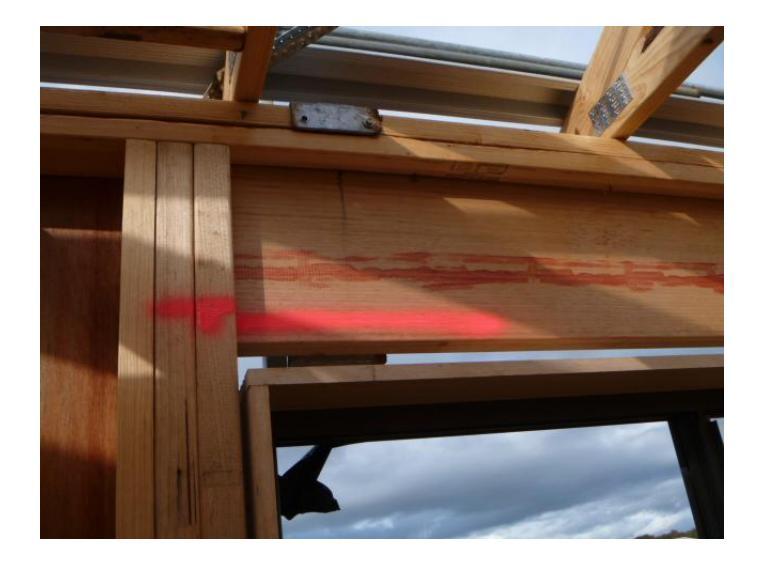
14. Theatre - the head of timber has not been installed to the internal lower side of the lintel, and as a result there is no support for plaster.

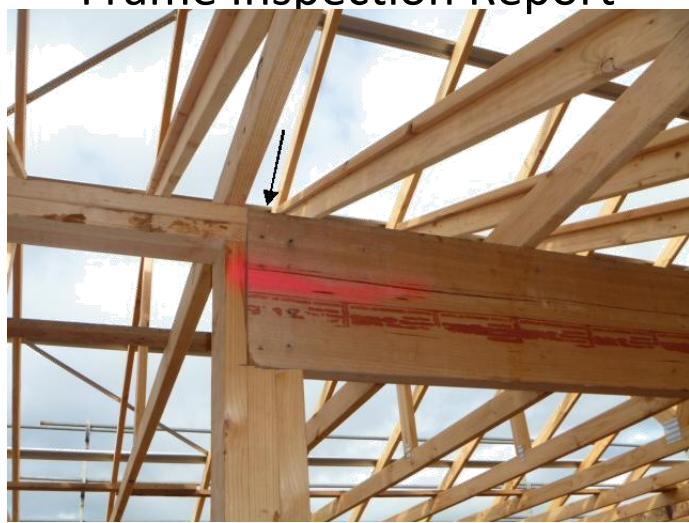
15. Living - The F17 lintel does not have a top plate carrying over the top of it as per AS1684.2 framing requirements.

The lintel is setup at a height that does not allow for the top plate to carry over the top of the lintel. The installed lintel could have been installed with a 35 mm top plate and enough room for the opening height below.

What the builder has caused is a point loading to a concentrated point at each truss connection. Having a top plate installed shares that point load over a more even surface.

This type of lintel installation creates a weak point in the frame. With wind loads can cause truss deflection and this can later lead to plaster cracking at these weakened points. AS per AS1684.2 - 2006, 6.3.6.1 the builder will need to install the top plate, or provide an engineered solution that will strengthen this junction point to alleviate ongoing plaster maintenance issues.

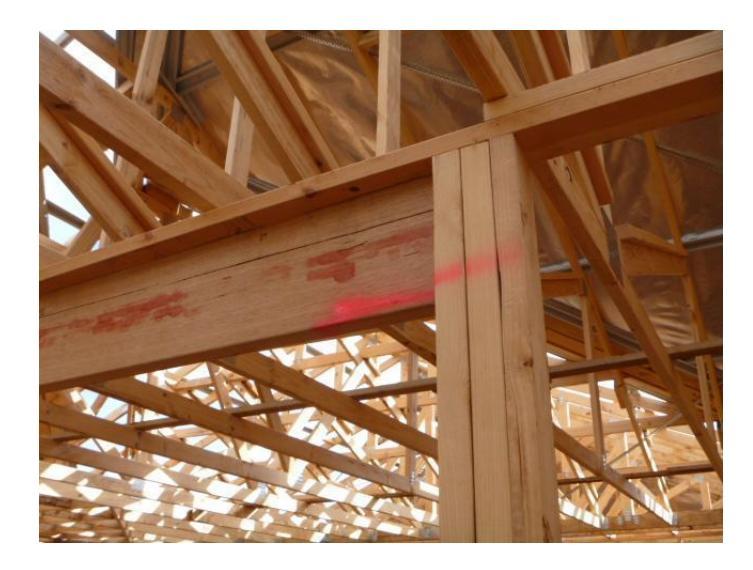
16. Living - the head trim has not been installed to the internal lower side of the lintel, as a result there is no support for plaster.

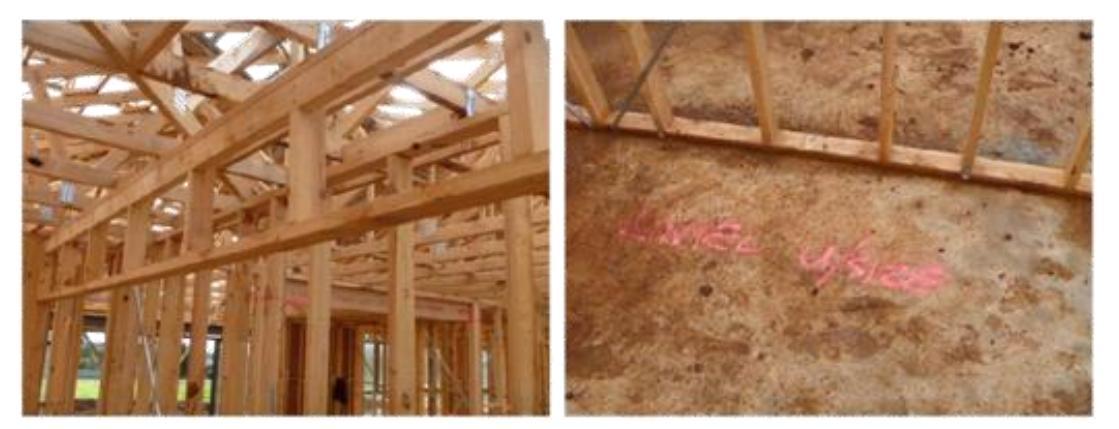
17. Laundry - The robe opening measures at 4270mm and as such will require installation of a larger lintel than currently installed.

AS 1684.2-2010 states that when openings in NON-LOADBEARING WALLS over 1800mm occur, both internal and external, a lintel shall be installed and the size of the lintel will be determine by table 23, based on the top plate.

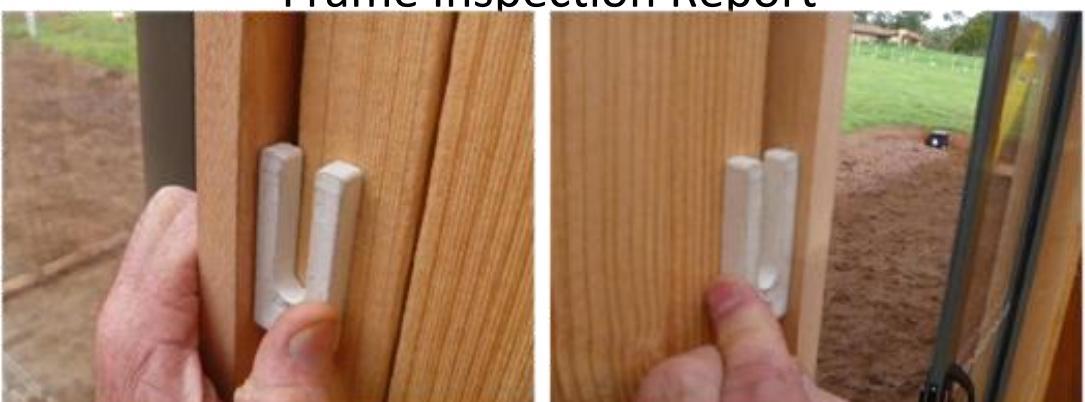
18. Laundry - the sliding door frame has been installed protruding more than 20 mm inside the wall frame line.

The builder will need to rework this door installation to 10 mm inside of the timber frame.

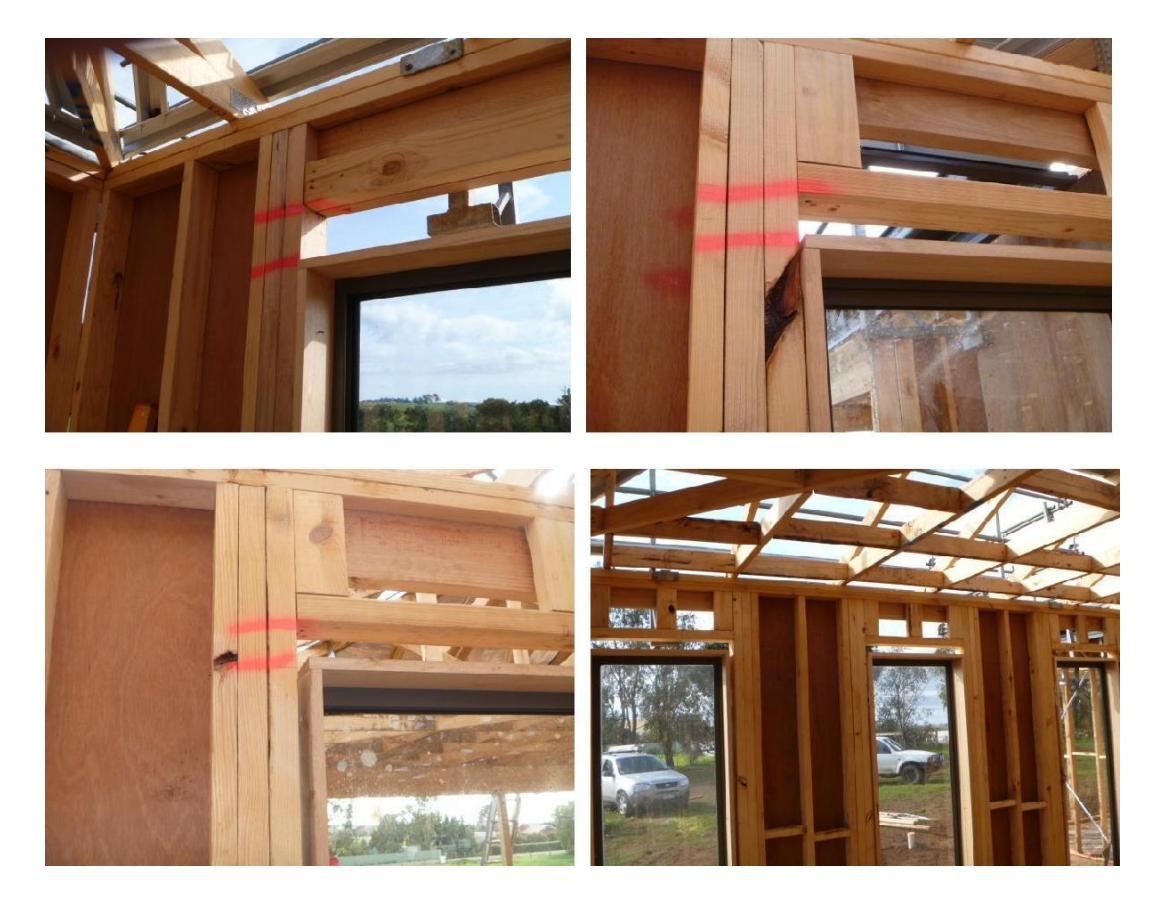
19. General - many of the window openings are excessively high and are presenting with a large gap above the windows and doors.

The builder will need to install trimming timbers underneath the lintels as support for plaster and architraves.

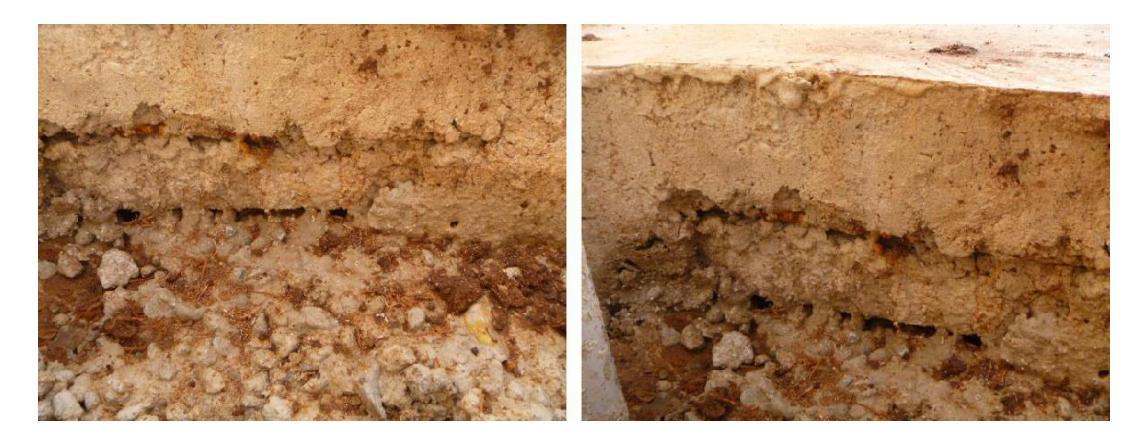
20. Bathroom - The bath waste recess is showing waffle pod Styrofoam and the steel reinforcement.

The builder will need to termite proof this hole in the slab before patching the concrete.

The builder will also need to supply an amended termite certificate to the owner that certifies the compliance of this rectification.

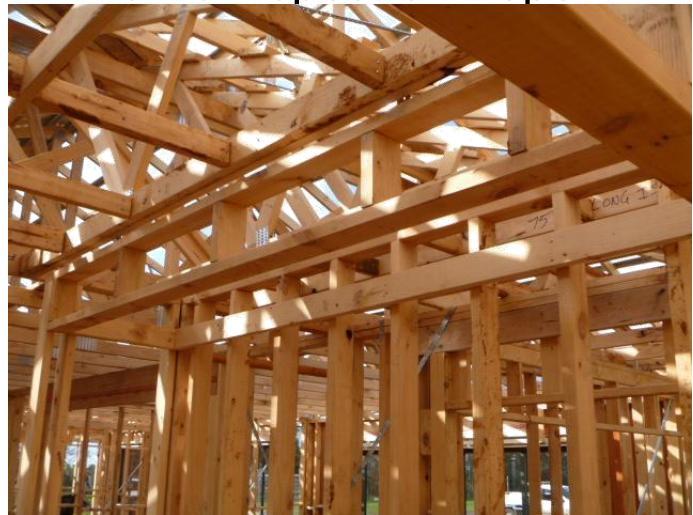
21. Kitchen - The bulkhead has been constructed without a lintel.

The builder will need to support this opening with a lintel installation that complies with AS 1684.2 Clause 6.2.5.2 inserted below.

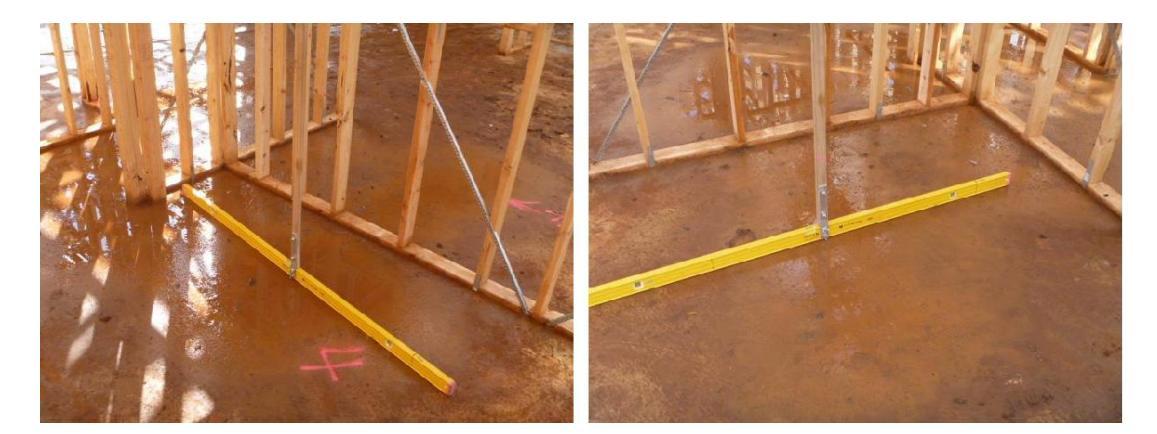
22. The concrete slab floors were checked using a 2.00m level. The majority of the floors are well within tolerance but a few are right on the 4 mm allowance.

If the builder is installing large porcelain tiles or floating timber floors then the 4 mm tolerance is not sufficient to allow a perfectly flat floor area and as such further works will need to be carried out.

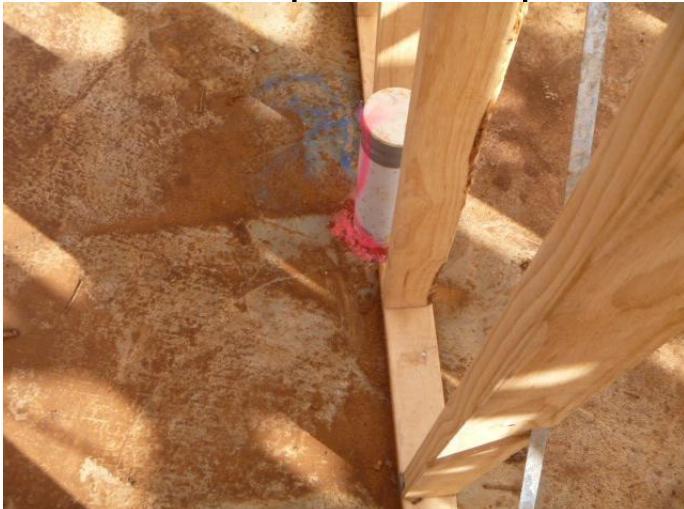
23. Bedroom three - the WC vanity waste pipe has been installed within bedroom three.

The builder will need to rework this plumbing installation to within the wall frame line, in a matter that does not interfere with carpet and skirtings in bedroom three.

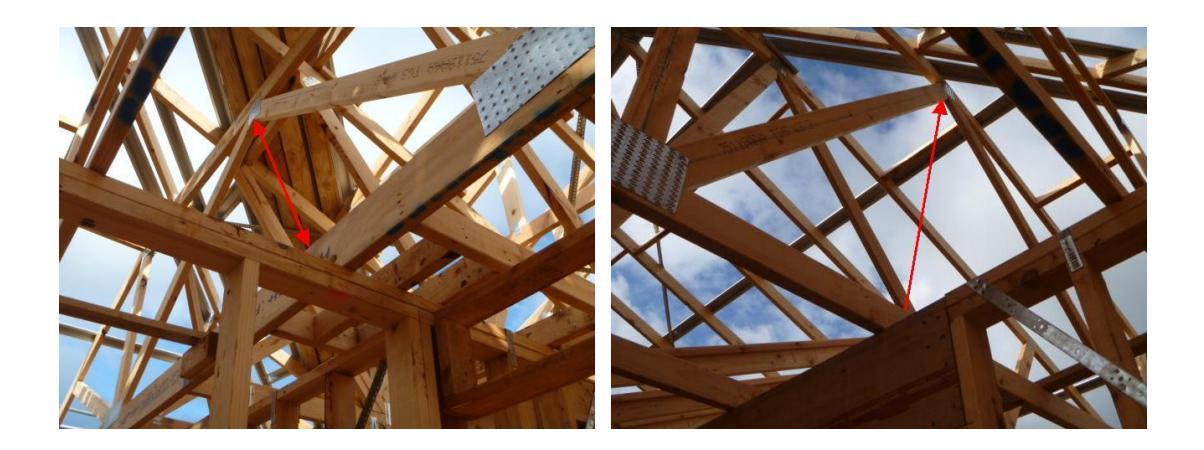
24. Living - the trusses have been installed as load-bearing over the centre wall.

The trusses do not show any form of web support as per normal load-bearing truss designs.

That truss supplier will need to substantiate this truss design and current installation.

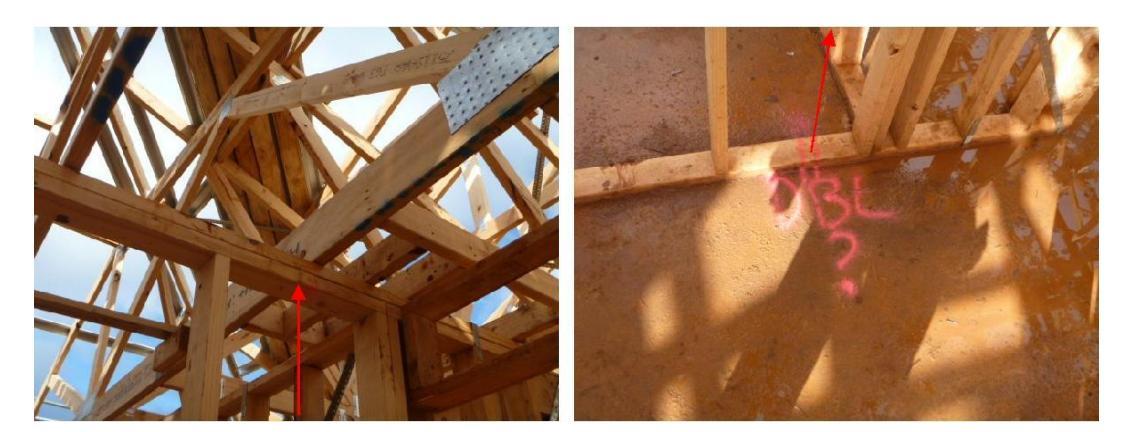
25. The central girder truss has been installed over the centre wall as load-bearing.It does not have double studs installed beneath this load bearing girder station.

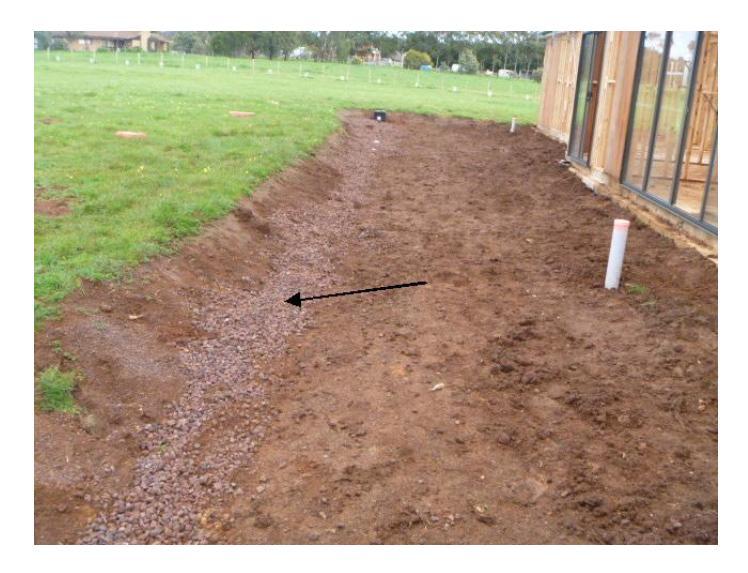
This central silt pit has not been installed as yet.

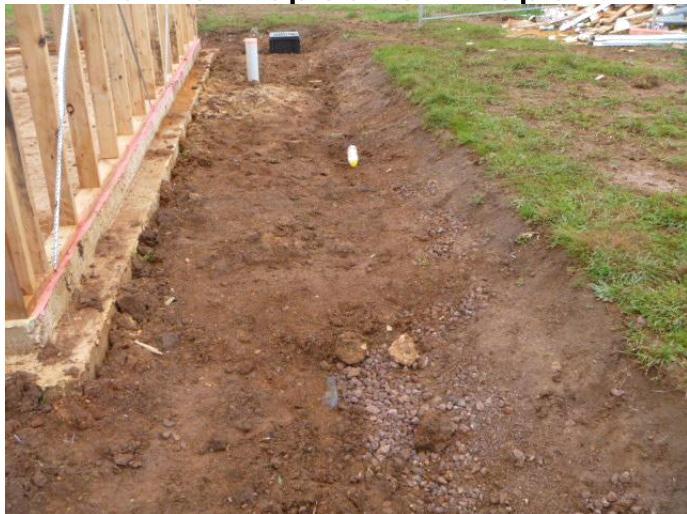
27. LHS - The AG drain system installed by the builder protecting my clients dwelling from surface water runoff is non-functional in this position.

I refer the builder and my client to the soil report and reason why the AG drain had to be installed which clearly defines that site water management during construction is important to the longevity of the foundations. As stated above, that system has not been maintained.

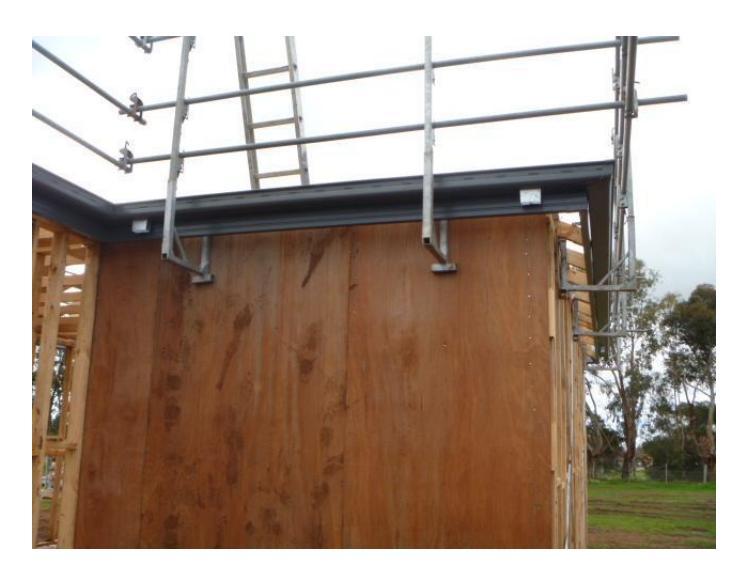
28. Garage - the plans show a single downpipe to the garage rear internal corner.

The builder has installed two downpipes being about 3 m apart. The builder will need to rework this installation to a single downpipe as per the plans.

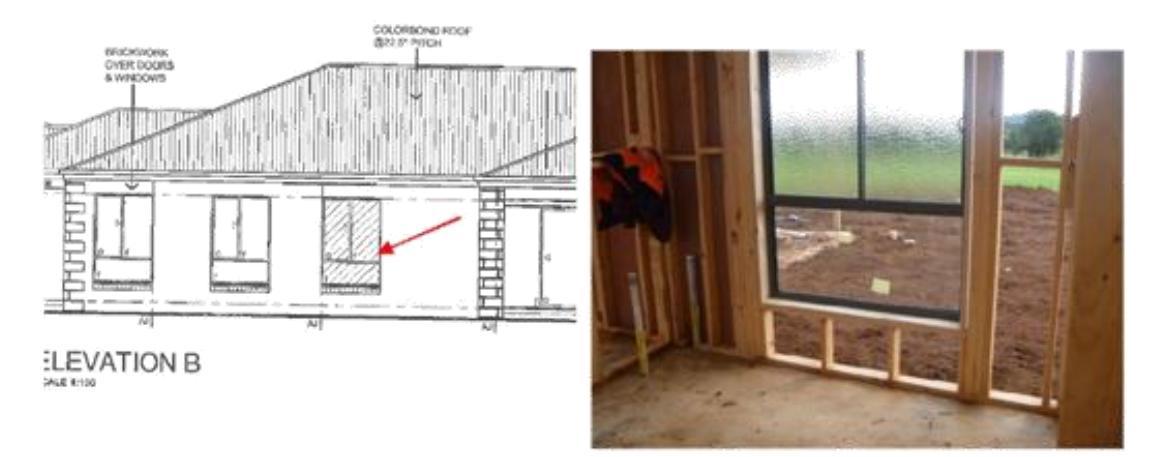
29. Ensuite - the plans stipulate frosted glass to the ensuite windows.

The builder will need to install the correct glass to the lower panel.
